Project information

70 sq m CC5
-   Fence Lining
-

Langely, BC
-

Weed suppression under fence at community garden

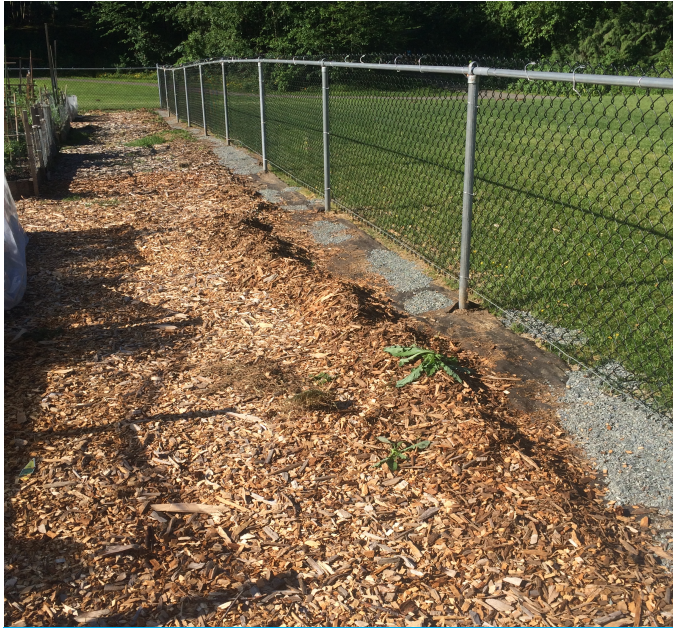
Site prior to installation

For site preparation, vegetation was removed and geotextile that was lining the garden was repositioned. Voids left by the root system of the weeds were filled with gravel. Batched rolls of CC5 were cut in half using a reciprocating saw.

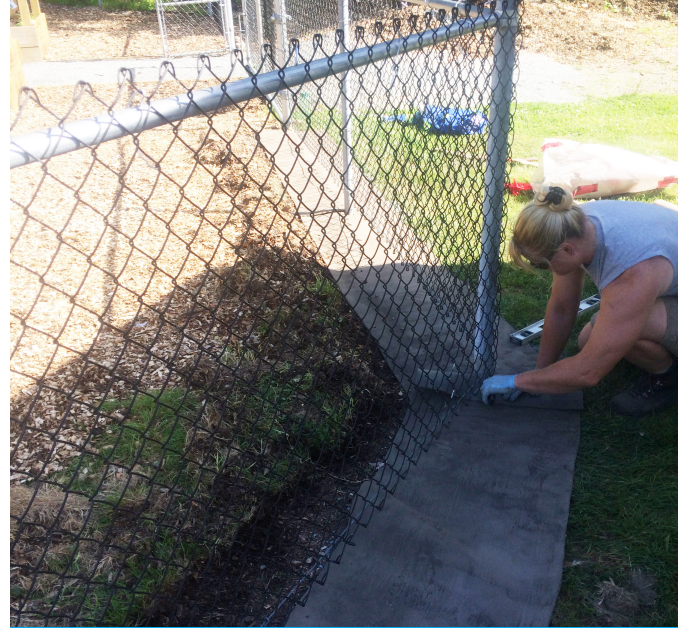
Installation of Concrete Canvas

Half rolls were laid out longitudinally along the fence line. The center point of the poles were marked and a hole saw was used to create holes in the material for the fence posts. The CC was cut from the middle of the hole to the edge so that it could be slipped around the post. The CC was then slid underneath the fence and positioned.

The edges were folded under 1 1/2" and held together with screws placed every 8". At points where a length of material ended and a new panel began, the material was overlapped by 4" and secured together with screws.

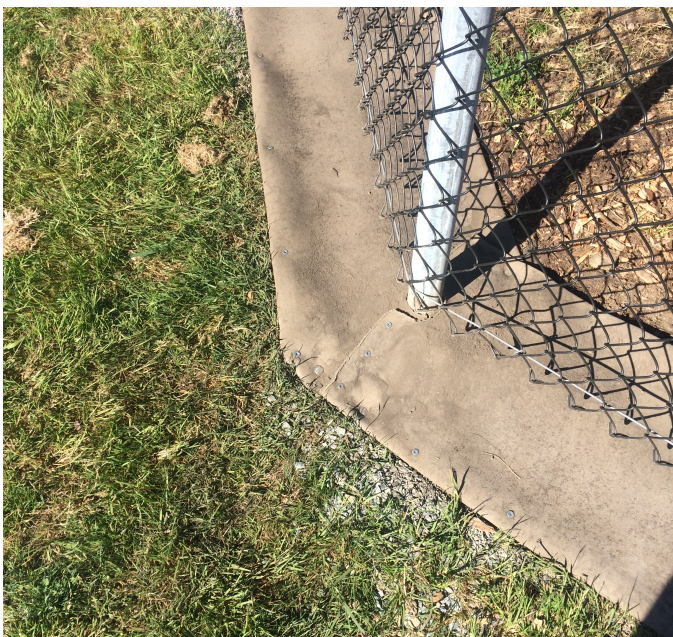
Grout used to prevent weed growth

The CC was hydrated using the on-site garden hoses at the community garden, and re-hydrated an hour later. On site temperatures during the installation reached a high of 28 degrees Celsius. Temperatures had dropped to 19 degrees during hydration. Once the CC had set, grout was used to fill the holes and joints to prevent weed growth, protecting the edges and to provide a finished aesthetic look. The installation crews were very pleased with the ease and speed of installation. They commented that it would have been incredibly difficult to use any other material in this situation because the fence line had already been placed. They appreciated that the CC could be easily slid underneath the existing fence without removal.

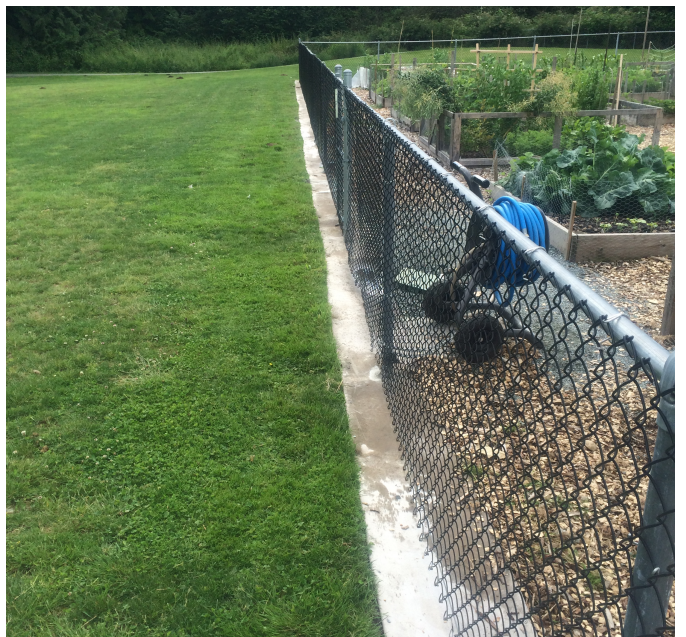
Length of completed project
