CC8™ and CC13™ Bulk Rolls

Willow Creek mine, British Columbia, Canada

CC8™ and CC13™ used to line a carrier drain channel directing contaminated water from a mine to a settling pond

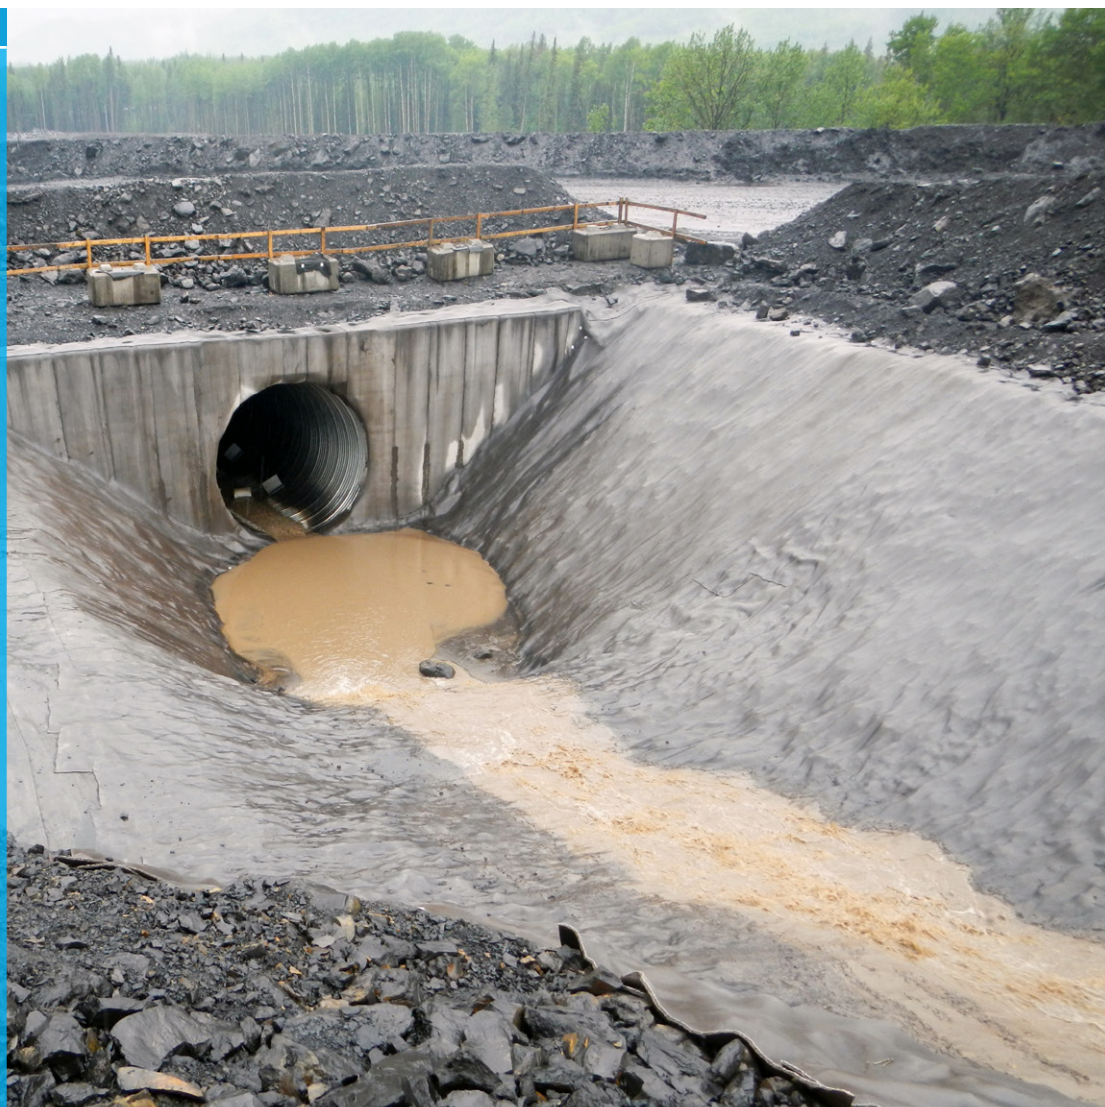
Completed lined channel and culvert

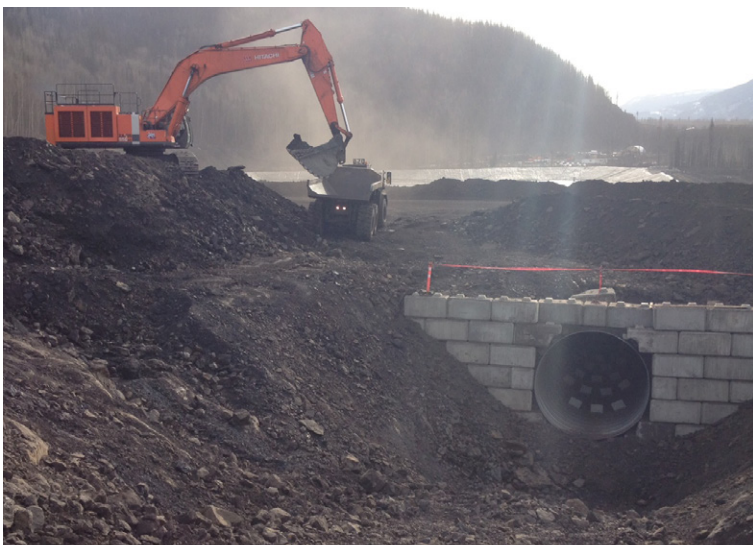
Excavating sump and constructing culvert

The channel terminated in a 4m diameter corrugated steel and concrete block work culvert and sump which was also lined with CC to ensure minimum water loss. This was imperative as the water was contaminated from tailings and could not come into contact with any other water sources.

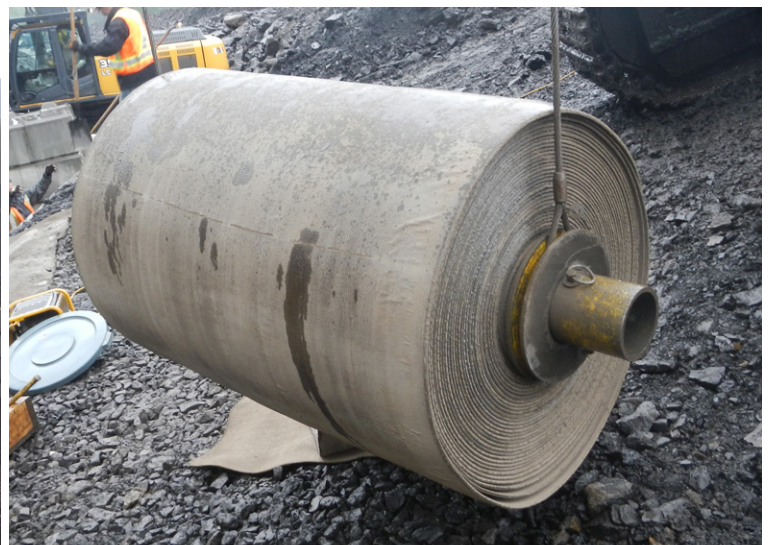
CC bulk rolls dispensed using spreader beam and plant

CC8™ and CC13™ were specified for the project and dispensed in bulk rolls from a spreader beam and plant equipment. The material was unrolled and cut to length on site, minimising waste as lengths were cut to match each section of the channel's profile. No perishable formwork or additional reinforcement was required.

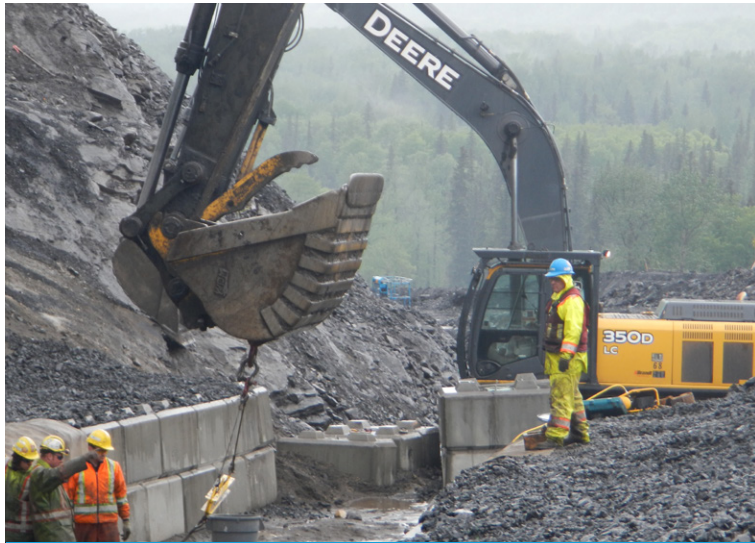
CC deployed across channel width

CC layers were laid transversely across the width of the channel, with subsequent layers overlapping by 100mm and beaded with Sikaflex 1A adhesive sealant to create water tight joints. Overlaps were jointed using 25mm screws to ensure intimate contact with the substrate. Where possible, end edges were buried with loose shale and aggregate to prevent water ingress under the CC and provide a neat termination.

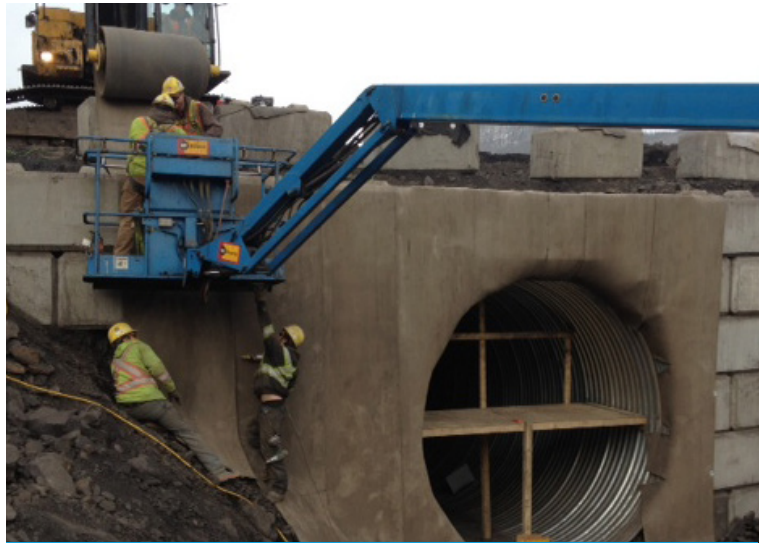
Lining culvert with CC8™

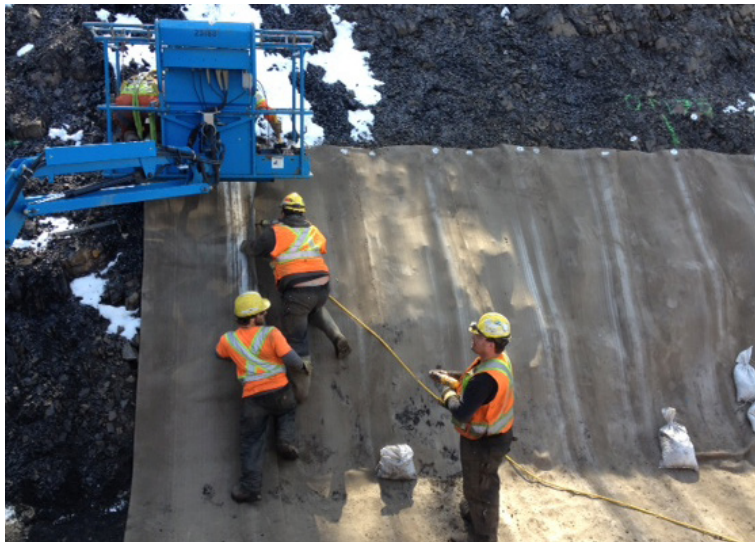
Applying Sikaflex beading to joints

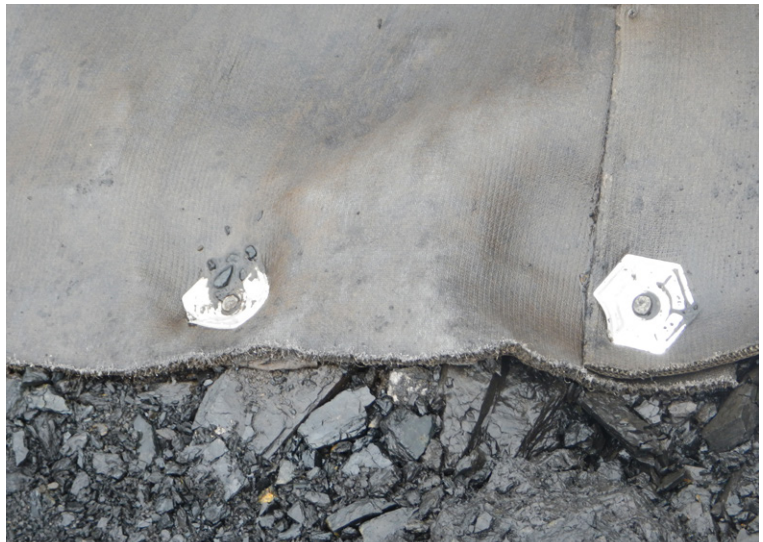
6" steel anchor nails with 1" hex head washers

The channel was excavated from a blasted rock substrate, with some sections reinforced with concrete block work. CC layers were pinned into position at the top of the profile using 10" Ardox galvanised spikes. When fixing CC to the concrete block work, Hilti rock anchors were used.

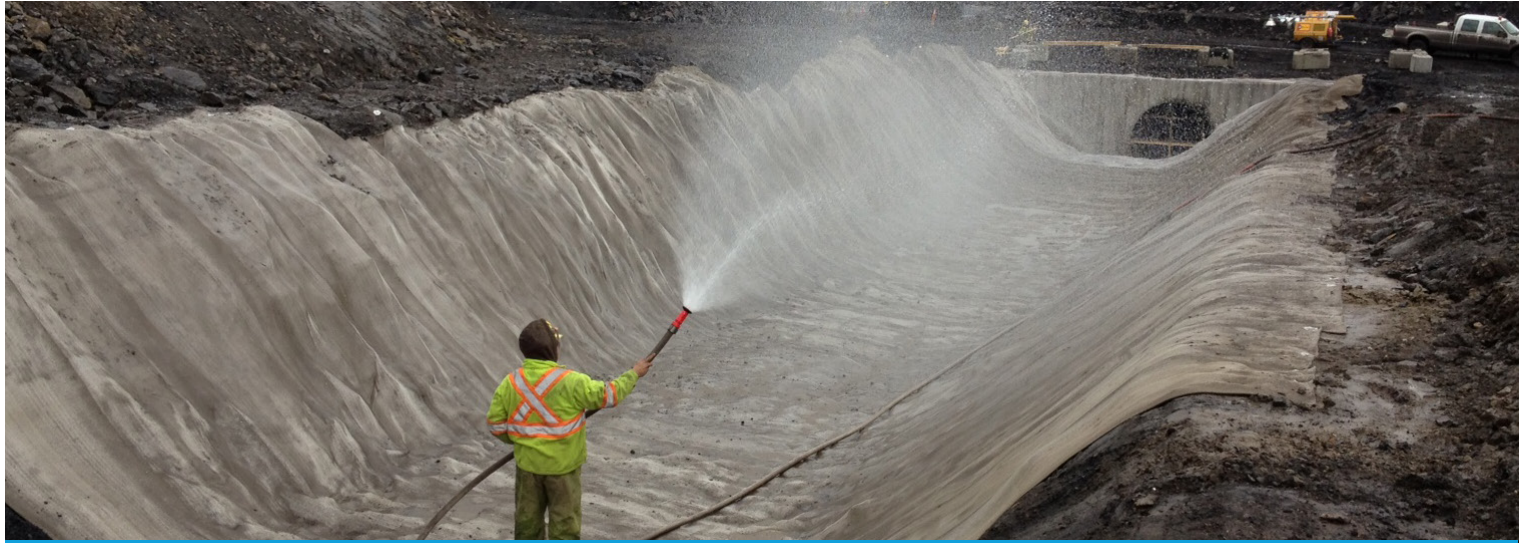
Hydration of lower channel section

CC has a working time of approximately two hours from hydration, meaning that work can continue in very wet conditions. This can reduce programme disruption typically caused by bad weather when using traditional concrete solutions. Plastic sheeting was used to protect the CC during setting when temperatures dropped to below -5°C.

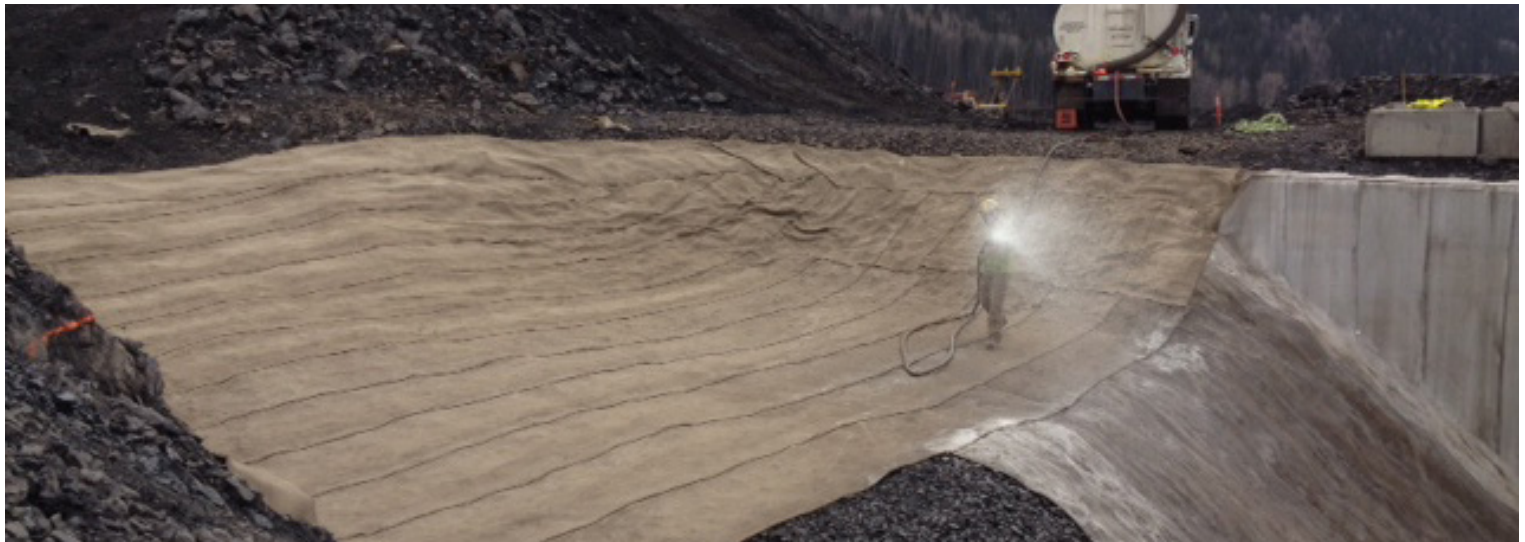
Hydration of top section of carrier channel

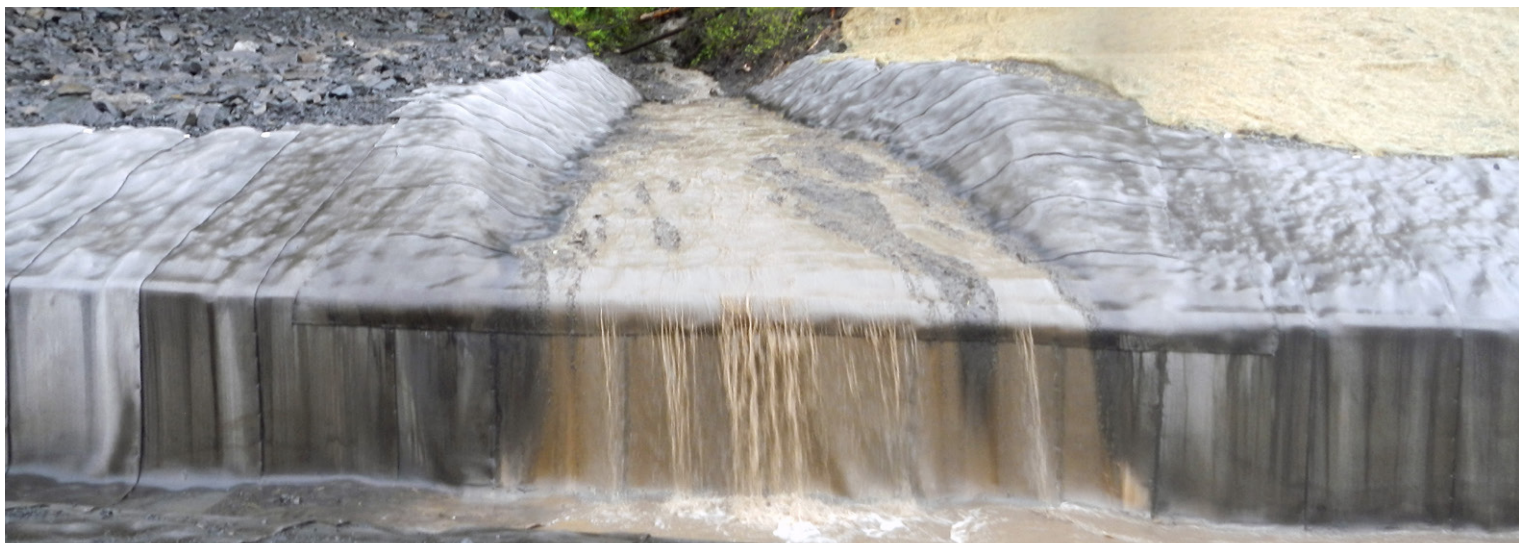
Swale was formed on the north ridge of the channel at a nearby tree line to collect surface rainfall from an adjacent hillside

A swale was formed on the north ridge of the ditch at a nearby tree line to collect surface rainfall from an adjacent hillside, using the ability of CC to closely follow the profile of existing slopes and negotiate tight bends and curvatures.

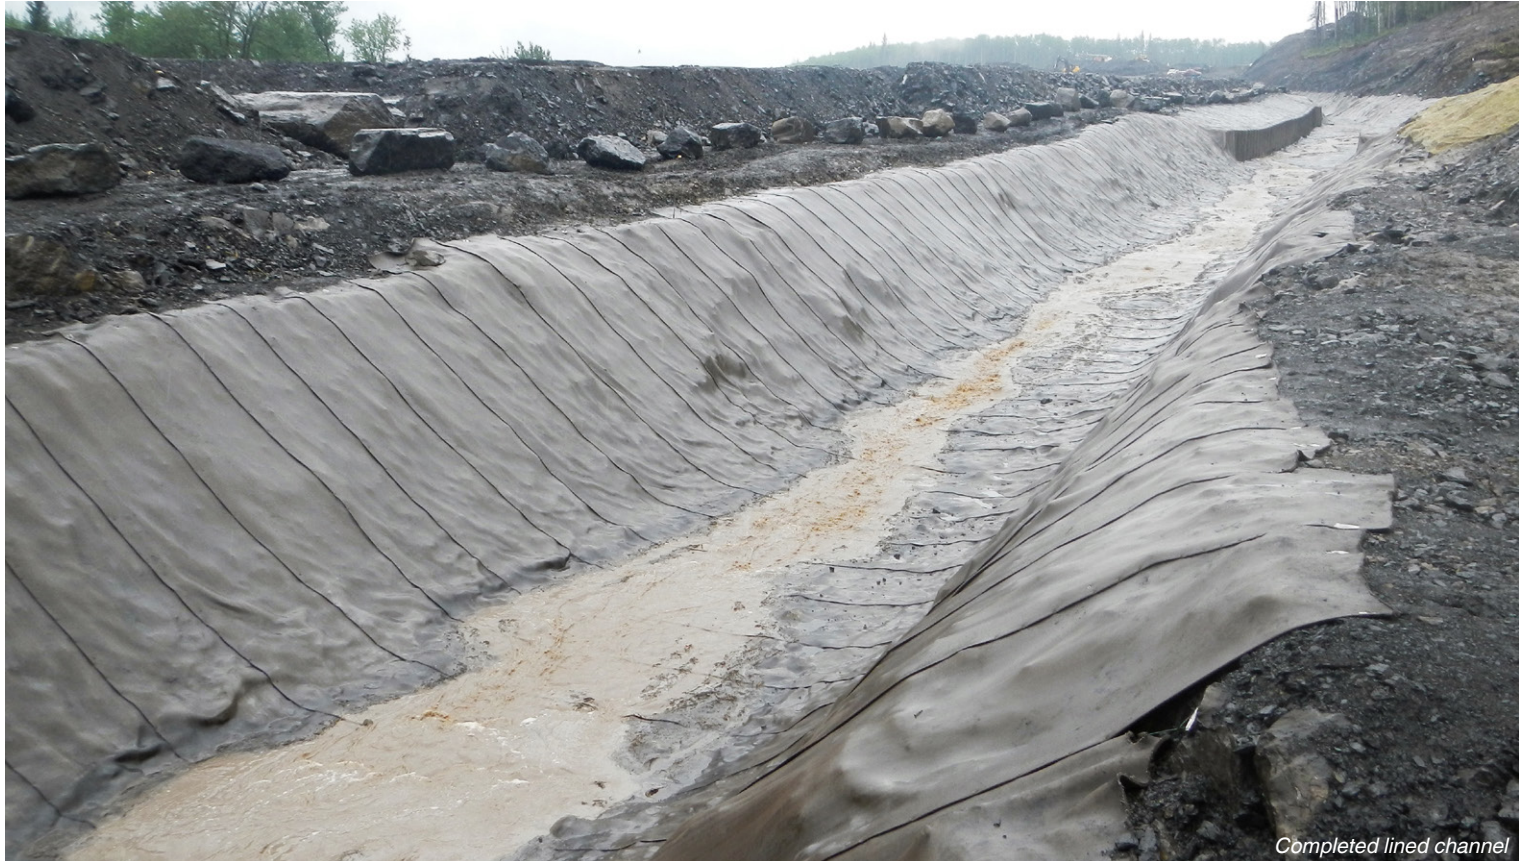
Completed lined channel

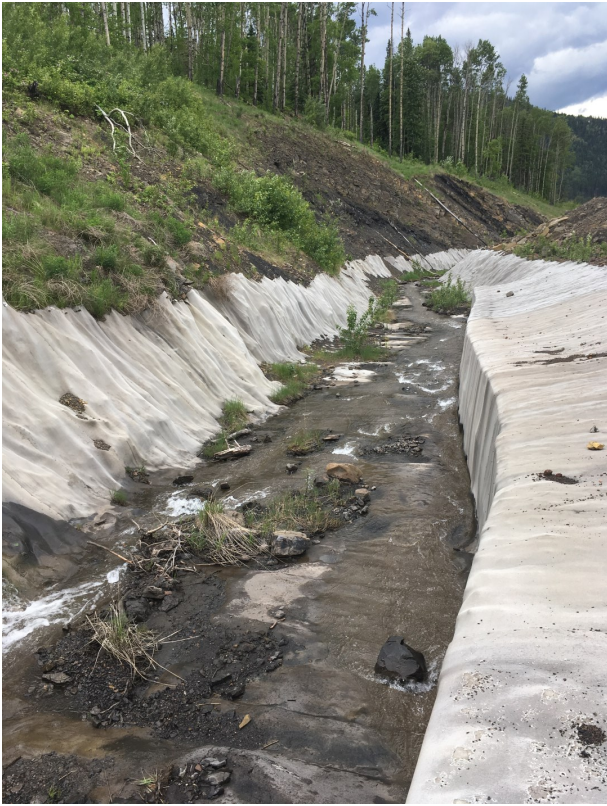
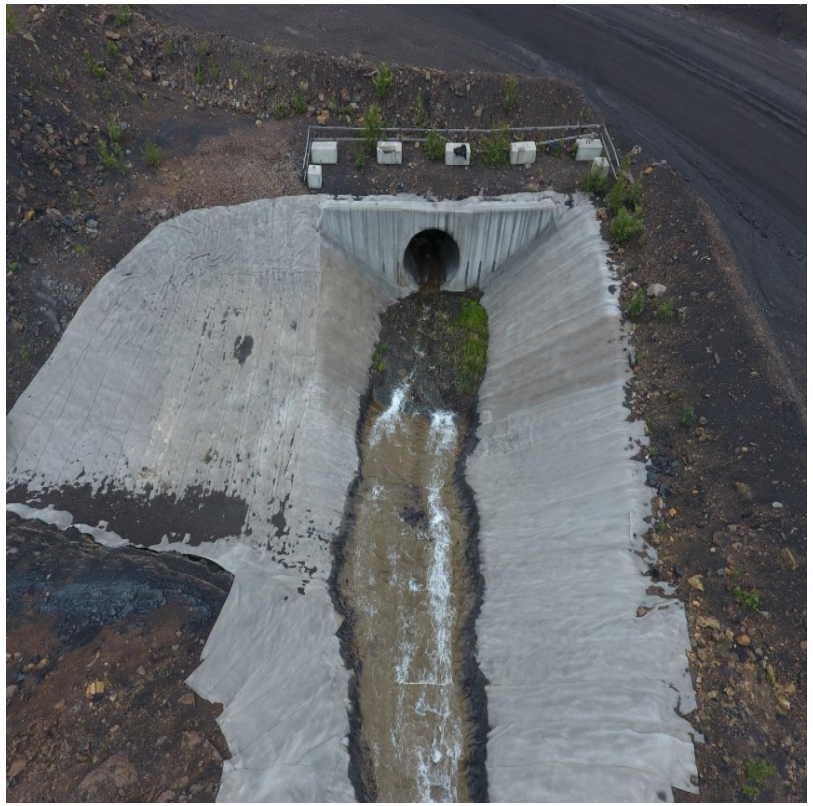
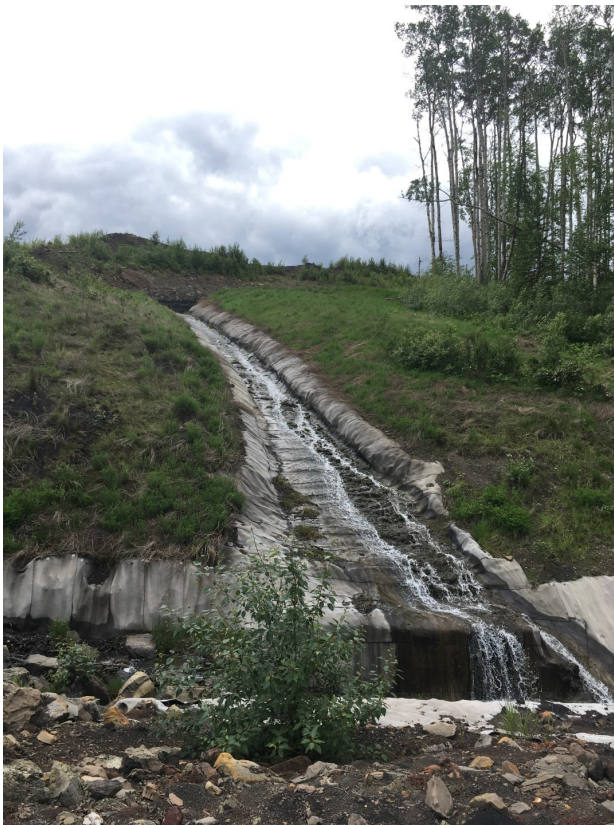
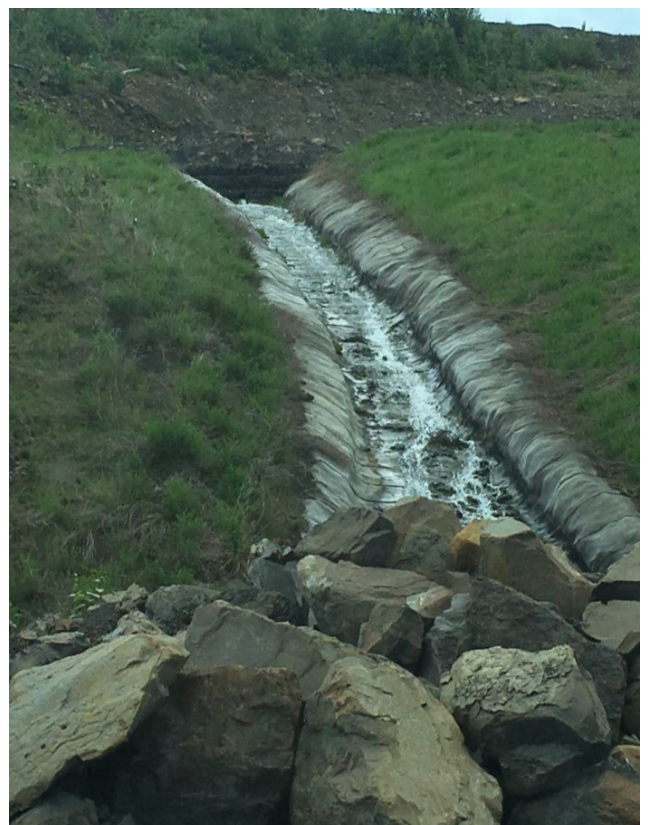
5 years later the ditch is holding strong with minimal damage and minimal vegetation growth. The Willow Creek Mine is currently in shut down but is slated to possibly re-open in the later part of 2017
