## Project information

Pipe Wrapping

Langley, BC

## Concrete Canvas Pipe wrapping- Initial trial

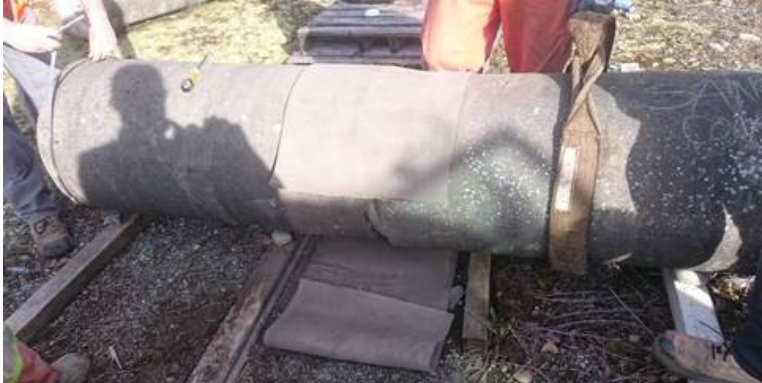
Old concrete pipe used as demo

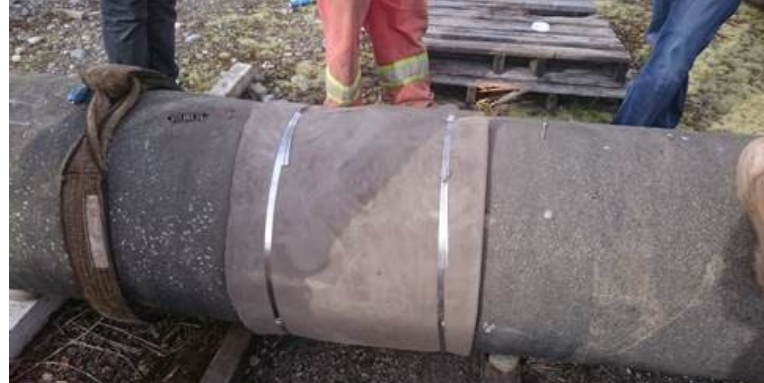
Various securing methods tested

For installation preparation, the earth was excavated around the pipes so that the area where the pipe are connected could be exposed. The CC was wrapped around the pipe and secured using Detlec Cable Strap Support. These strap supports act as larg "zap straps" and are very easy to position and tighten. In the initial trial installation, crews used metal hose clamps to secure the material to the pipe, however they found the screw tightening system to be ineffective and time consuming. No sealant was required. The CC was then hydrated. In one instance crews had to use water filled jerrycans to perform hydration.

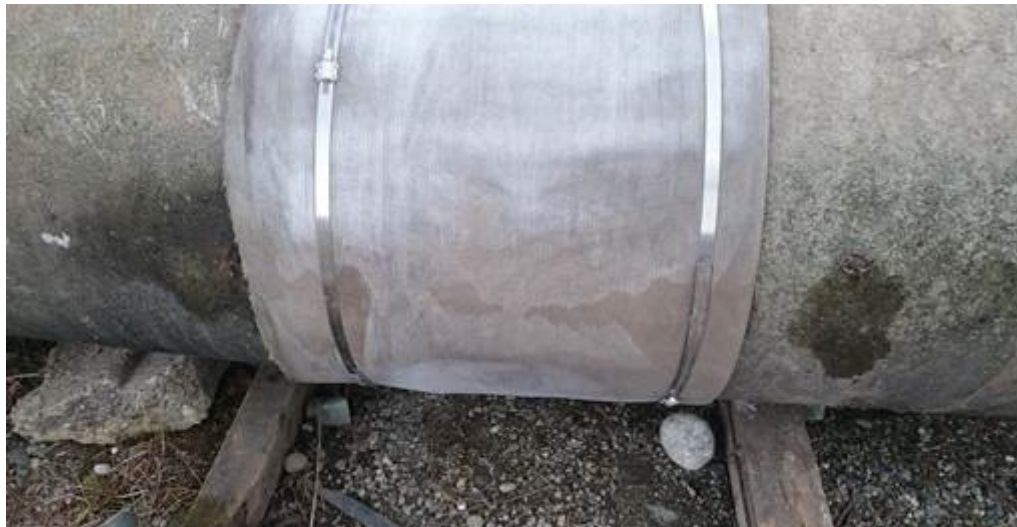
CC hydrated and set with decisions made on final installation techniques

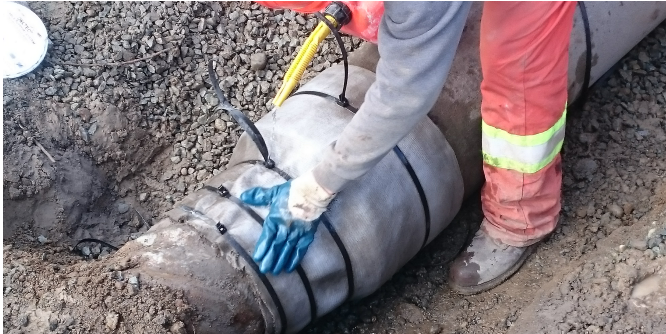
Deltec Cable Strap support used

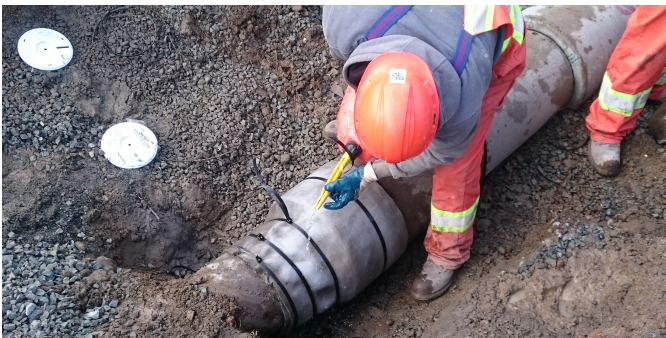
Hydration using a water filled jerrycan

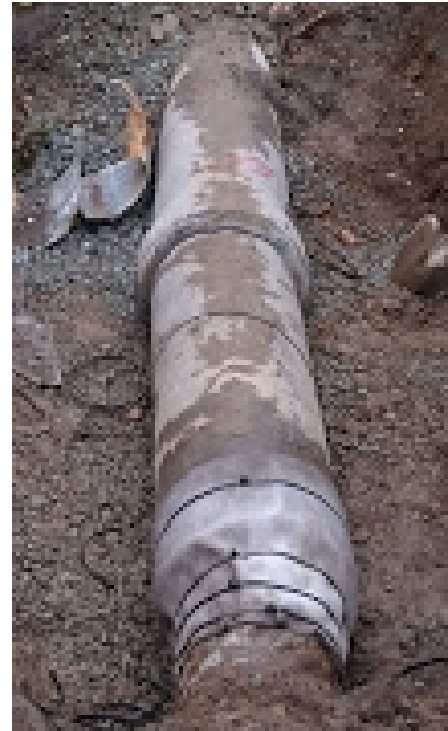
Completed CC pipe wrap

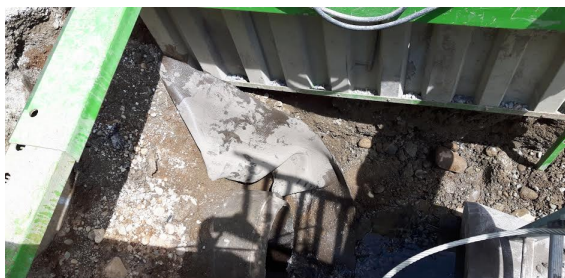
Storm main replacement

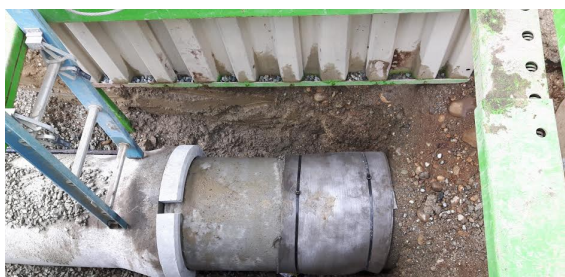
CC hydrated and set in place

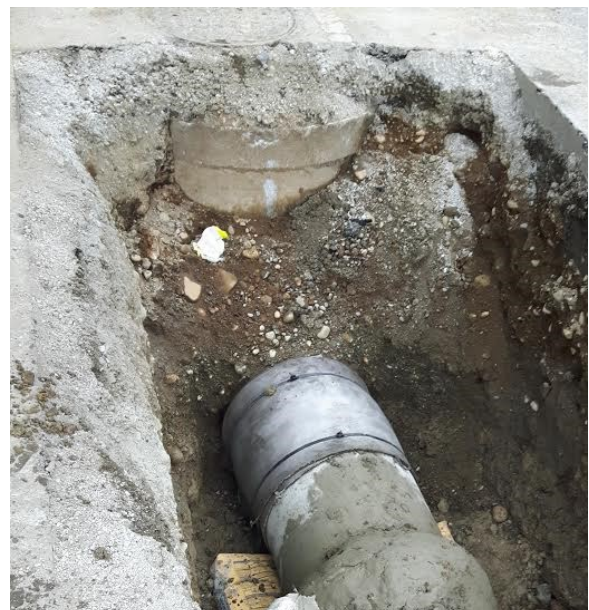
completed project
