CC5™ and CC8™ Bulk Rolls

Pogo Mine, Alaska, USA

CC5™ and CC8™ used to remediate a dilapidated shotcrete drainage ditch

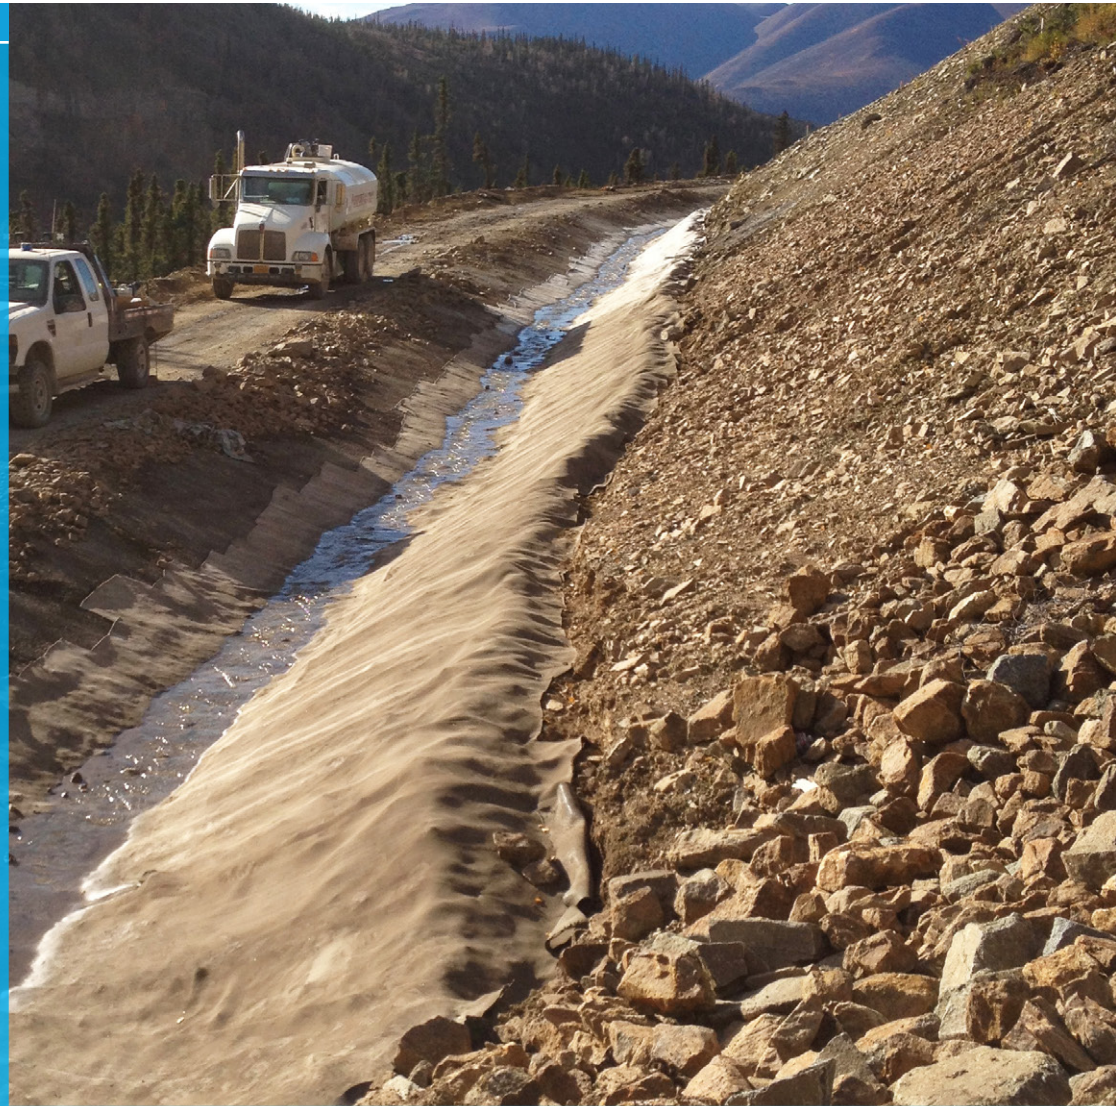
*Completed section of ditch*

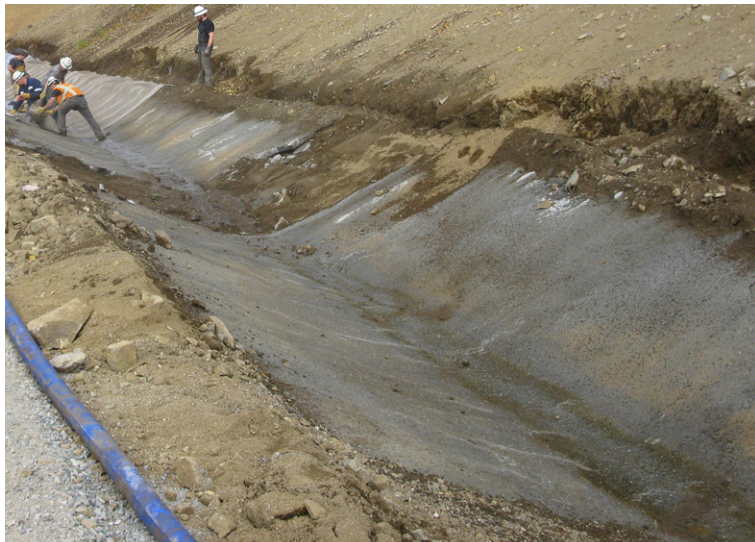
Re-lining the ditch with shotcrete was considered, however 2 miles of shotcrete lined ditches had been installed in the previous two years and proved this was not a long term solution. Storm water had undermined the ditch which, when coupled with freeze-thaw weathering and heavy spring rains, had caused extensive cracking of the shotcrete leading to failure.

Slope causing the runoff undermining the shotcrete ditch

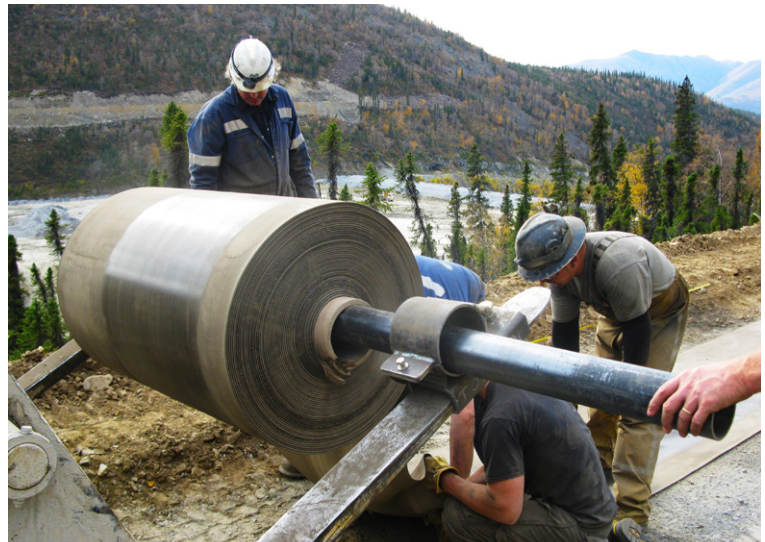
CC mounted to Caterpillar small wheel loader

The CC was mounted onto a Caterpillar small wheel loader with a spreader beam, unrolled and cut to specific profile length with a utility knife to avoid wastage. The mine staff then laid the CC transversely, overlapping layers in the direction of water flow. The outer edges on the side adjacent to the slope were fixed with 305mm Galvanized Ardox spikes into the previously created anchor trench. The overlaps were screwed every 300mm with 20mm truss head stainless steel full thread screws. The roadside edge of the CC was then sealed with a bead of Sikaflex 1A and fixed into the existing shotcrete liner with 15mm x 10mm steel mushroom anchors. The material was hydrated via a water truck with a 50mm adjustable nozzle.

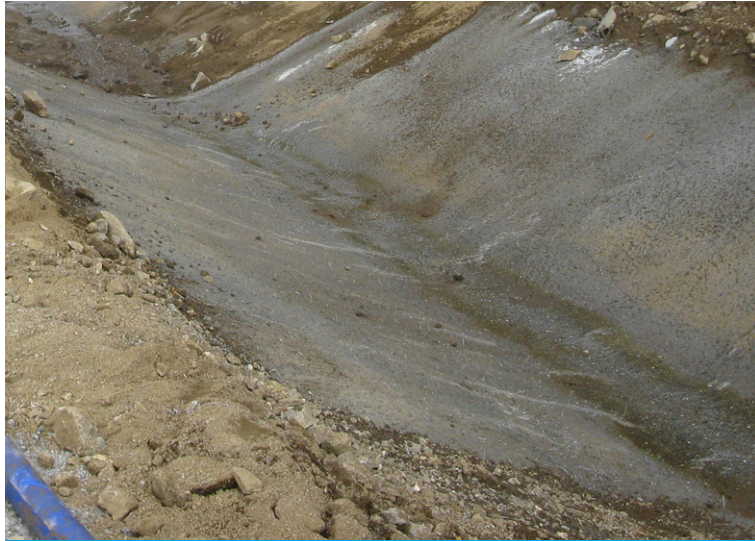
Existing shotcrete ditch

33 Bulk rolls of CC5™ and 5 bulk rolls of CC8™ were delivered to Pogo Mine. The existing shotcrete ditch was cleaned of debris such as rock and vegetation to ensure intimate contact between the CC and the incumbent shotcrete lining. An anchor trench was created at the crest of the ditch adjacent to the slope, above the level of the existing shotcrete, to prevent runoff water from the slope infiltrating under the CC. The opposite side of the ditch is located next to a road, for which the bank was graded and the ditch was re-profiled using a Volvo EC360C and a Caterpillar 320C excavator.

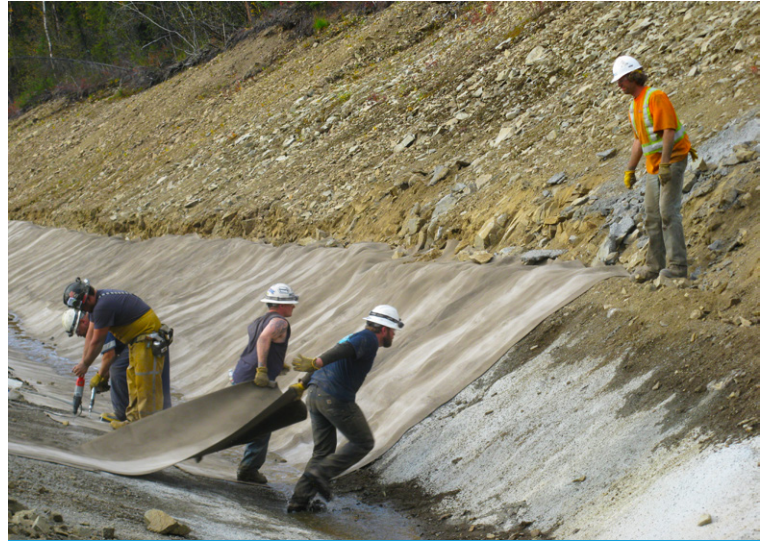
Unrolling the CC5

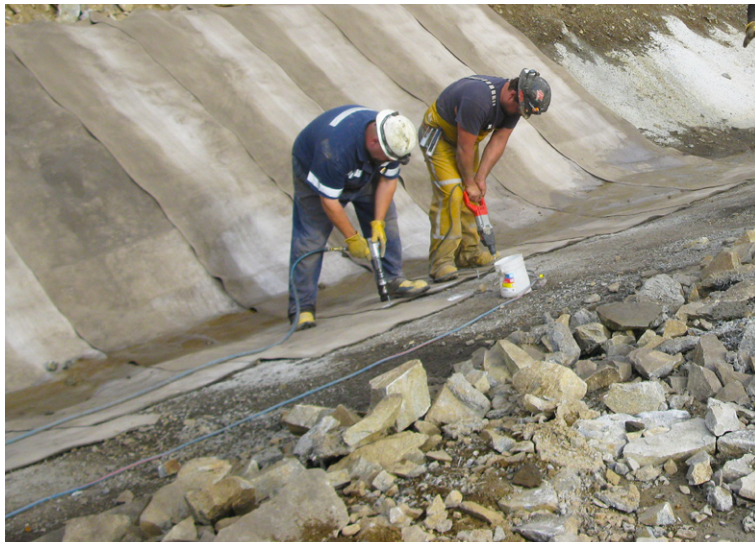
Fixing the CC to the existing concrete

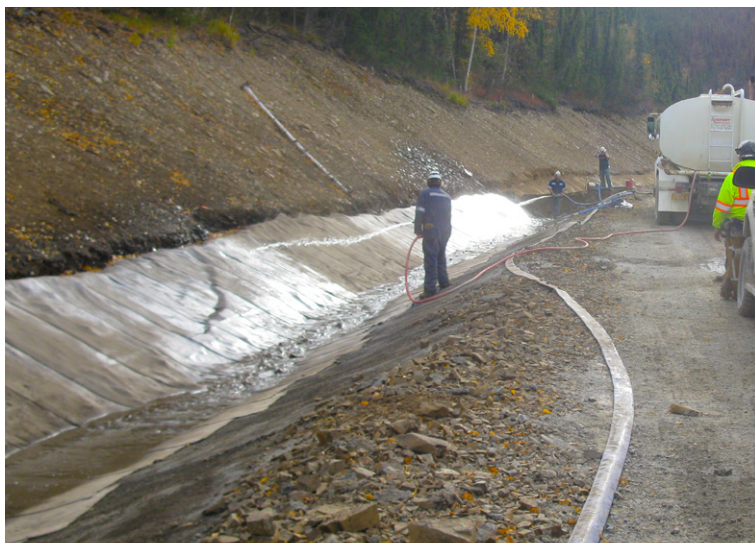
Hydration

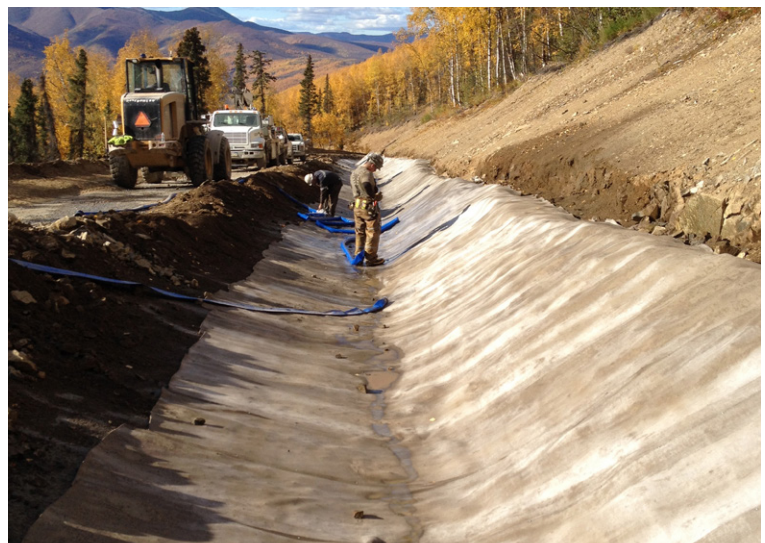
CC post-hydration

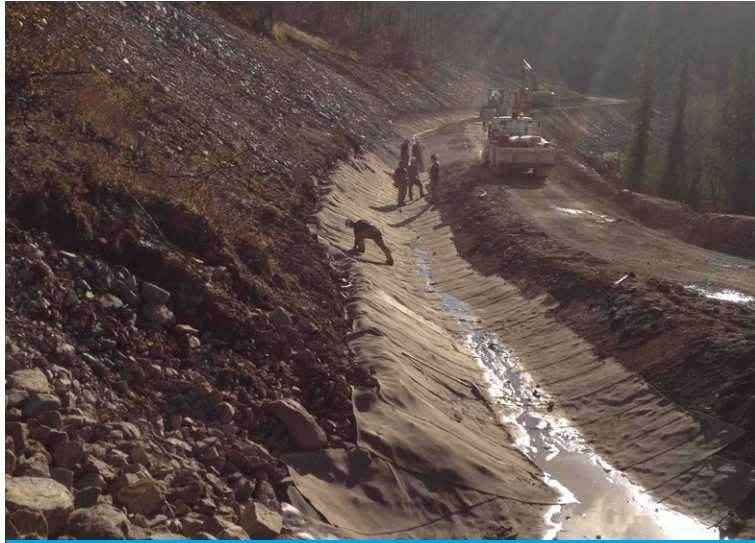
A section of the completed ditch

A total of 7,225m<sup>2</sup> of CC was installed in 11 days at rate of up to 1000m<sup>2</sup> per day by a team of 6, in low temperatures. The install was deemed a success due to the speed of install and a huge cost saving of 90%.

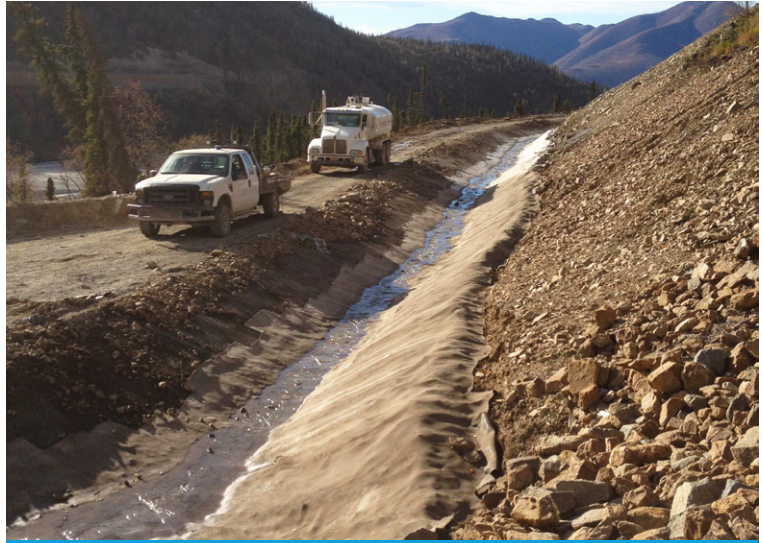
A section of the completed ditch

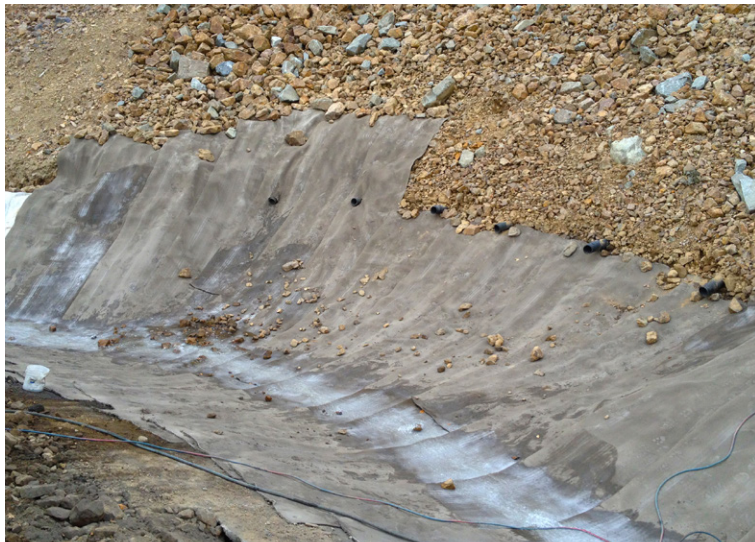
Corner and infrastructure accommodation

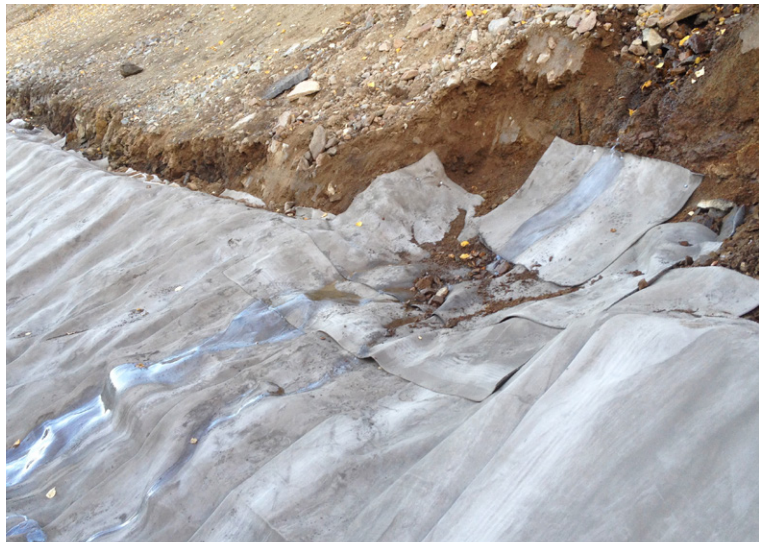
Water inlet
